Design and Construction of a ClosureTurf® Final Cover System

Dillon Baird, PE
Paul Migwi, EIT

SCS ENGINEERS

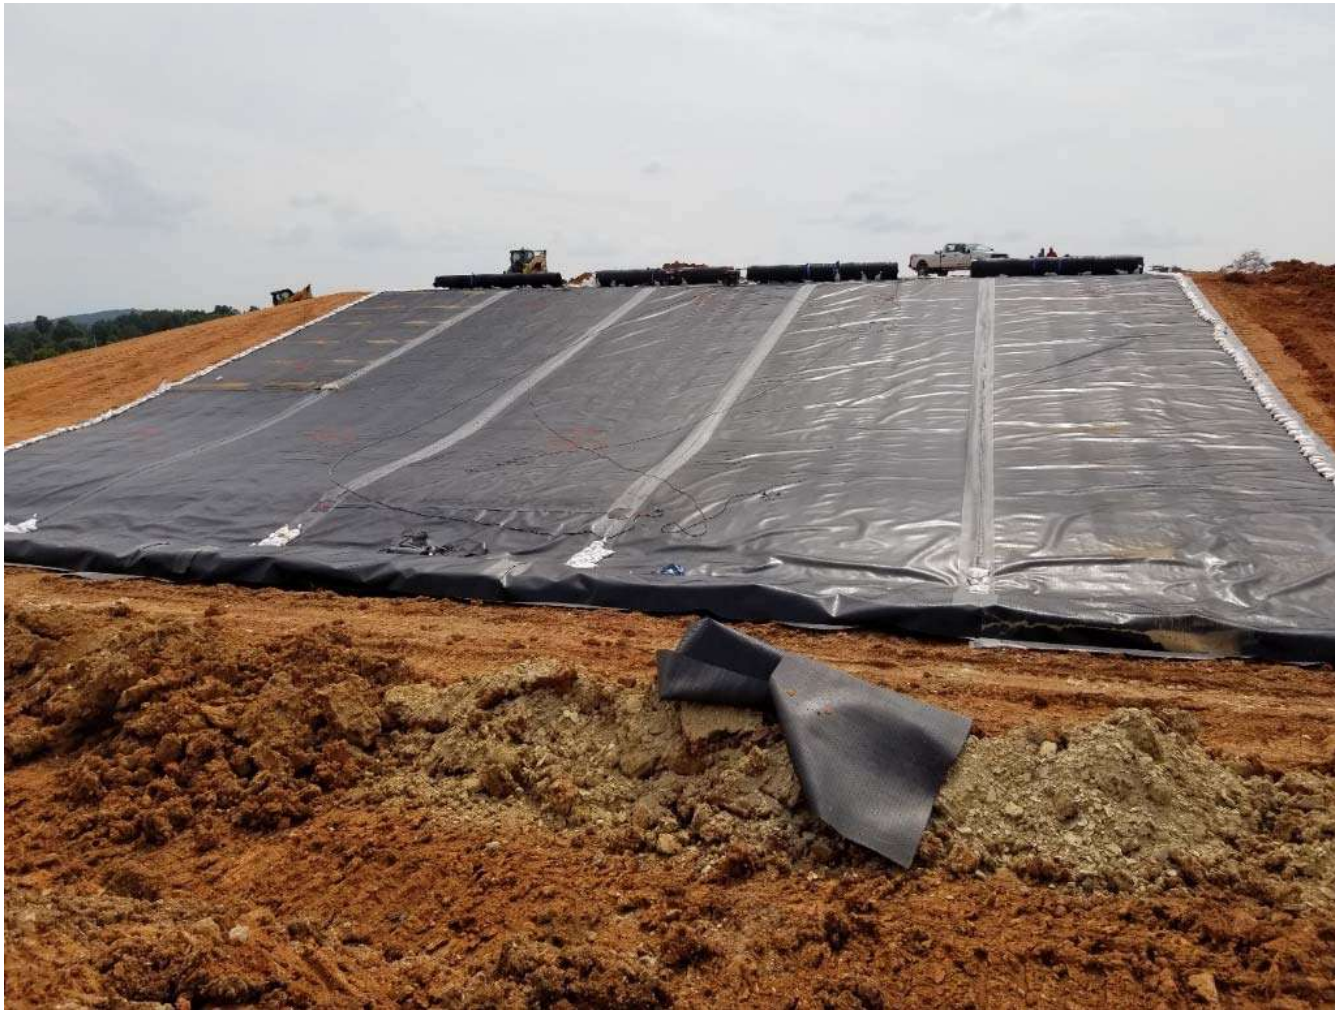
- 50-mil HDPE SuperGripnet is rolled out onto subgrade.
- Panels are joined using fusion/extrusion welding techniques.

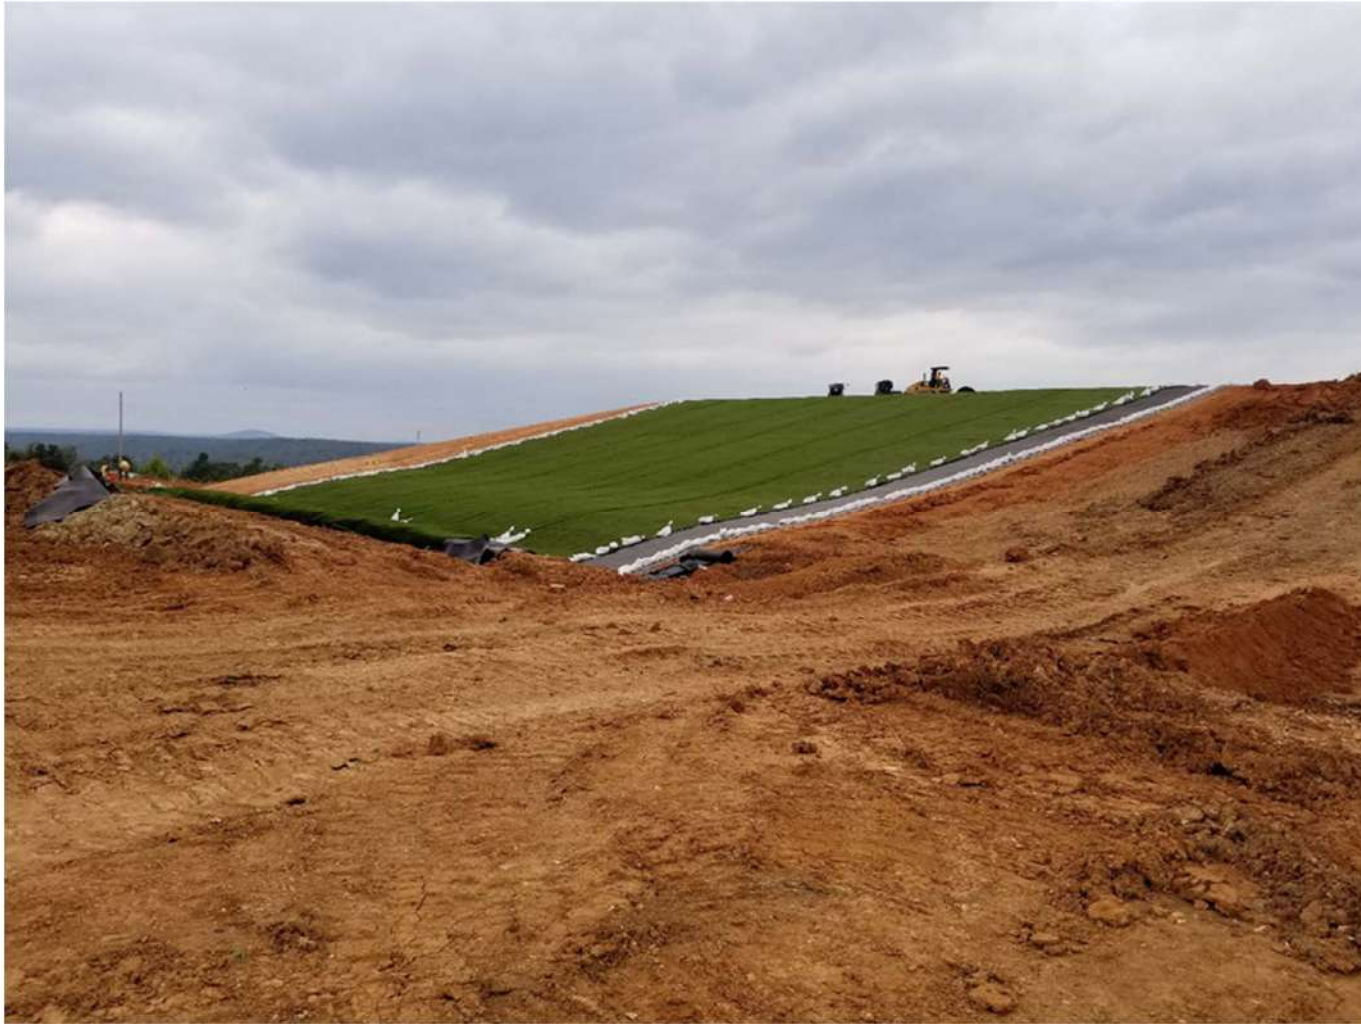
- Turf is then rolled out on top of the liner and turf panels are seamed together utilizing heat.

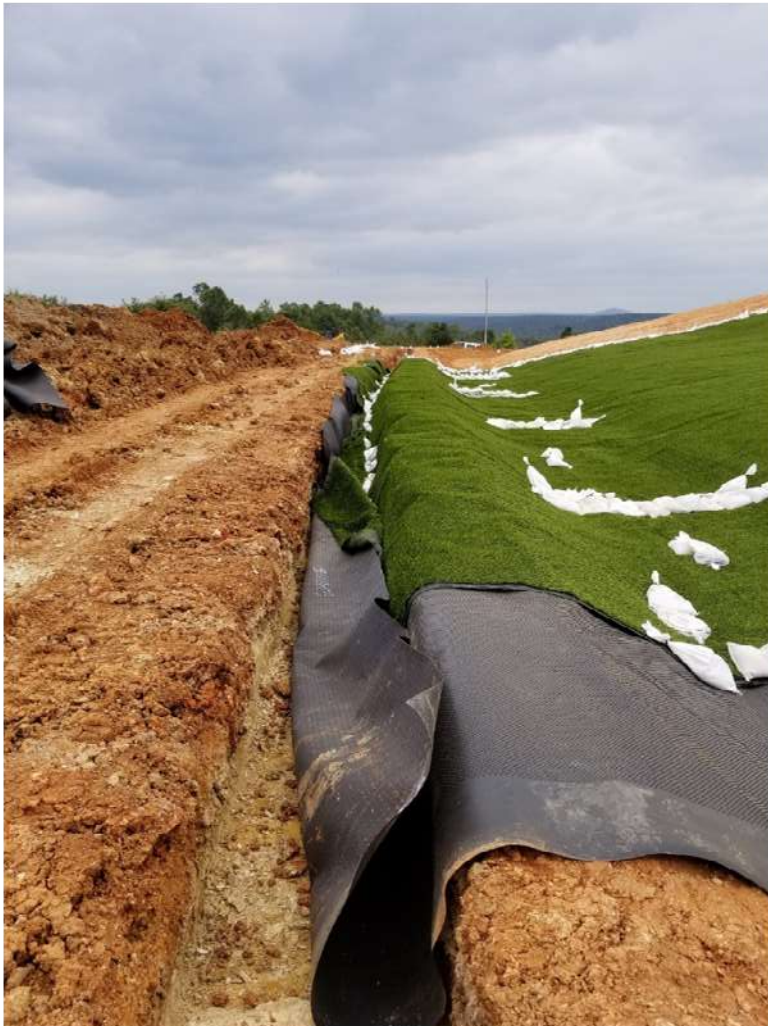
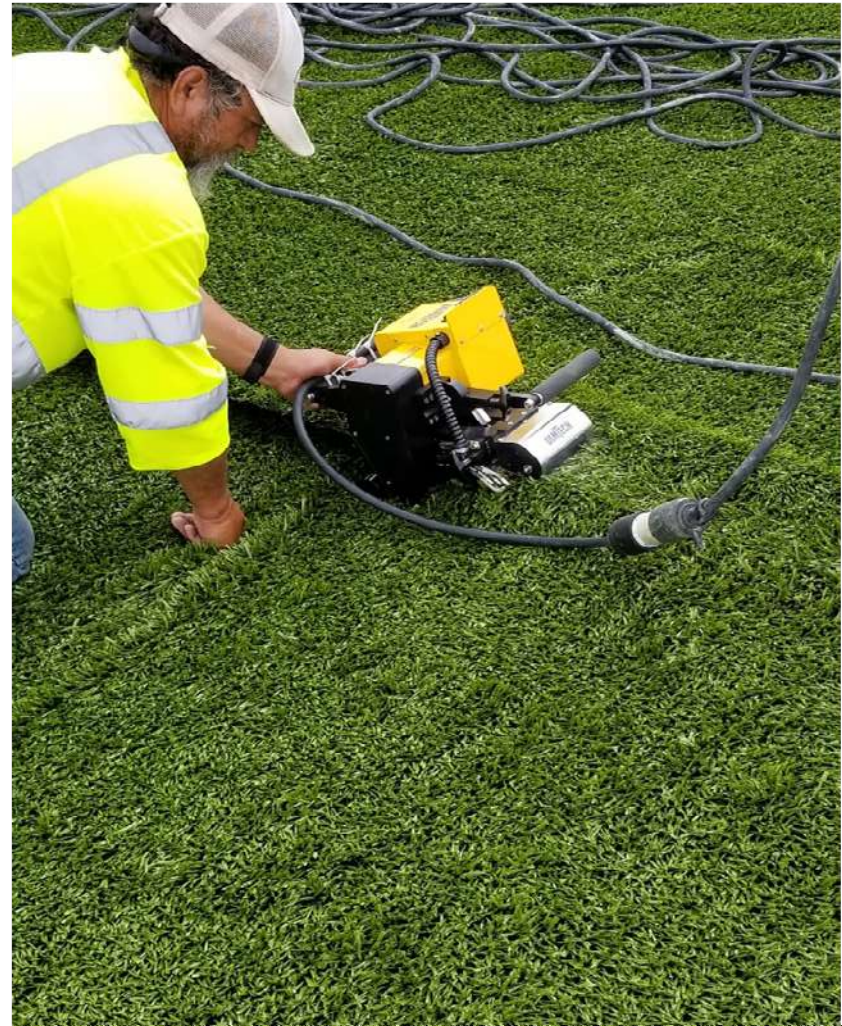
- Geosynthetics are secured in an anchor trench.
- Panels of turf are joined by heat.

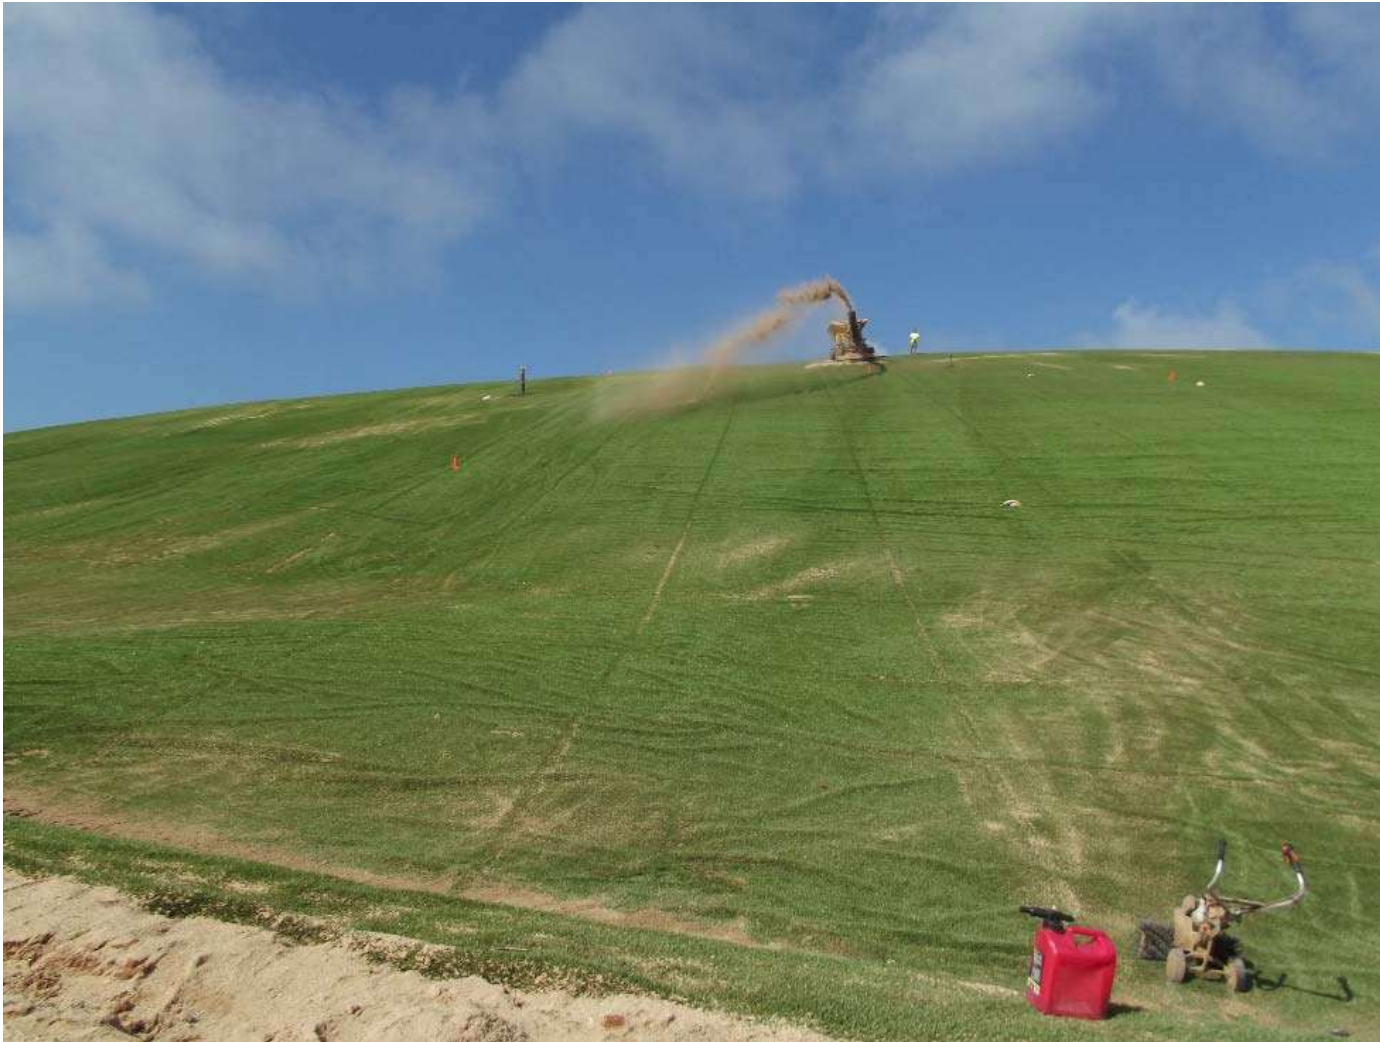
- Sand is spread to a thickness of ½ inch thick.
- The sand is then brushed into the turf fibers.

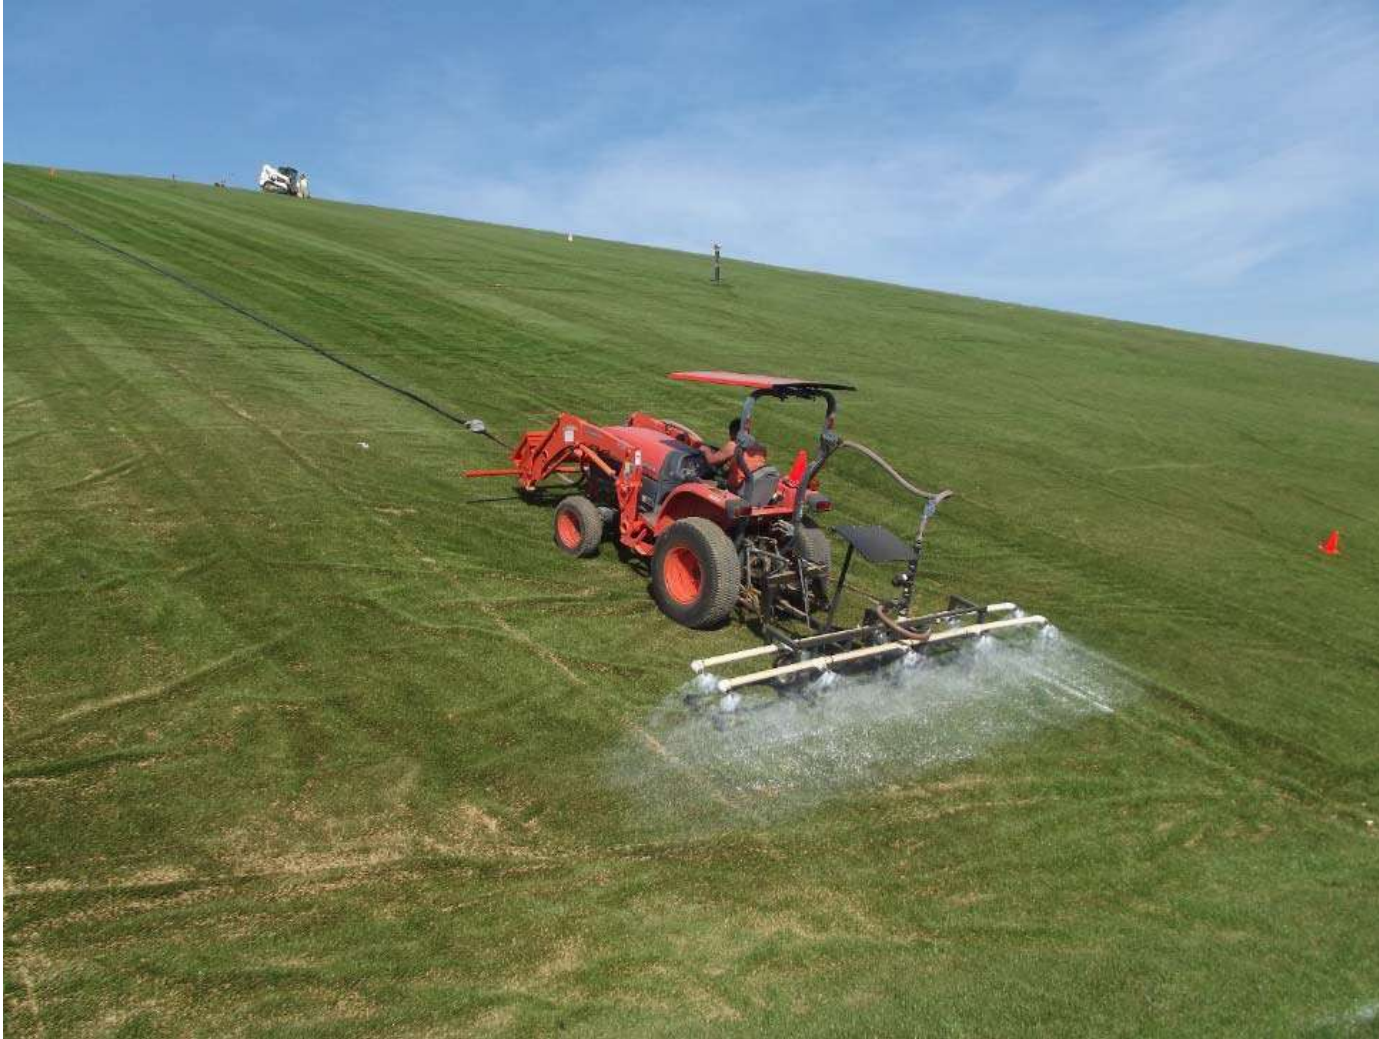
- ArmorFill is then placed on the sand to provide a durable protective coating and prevent sand from washing away.

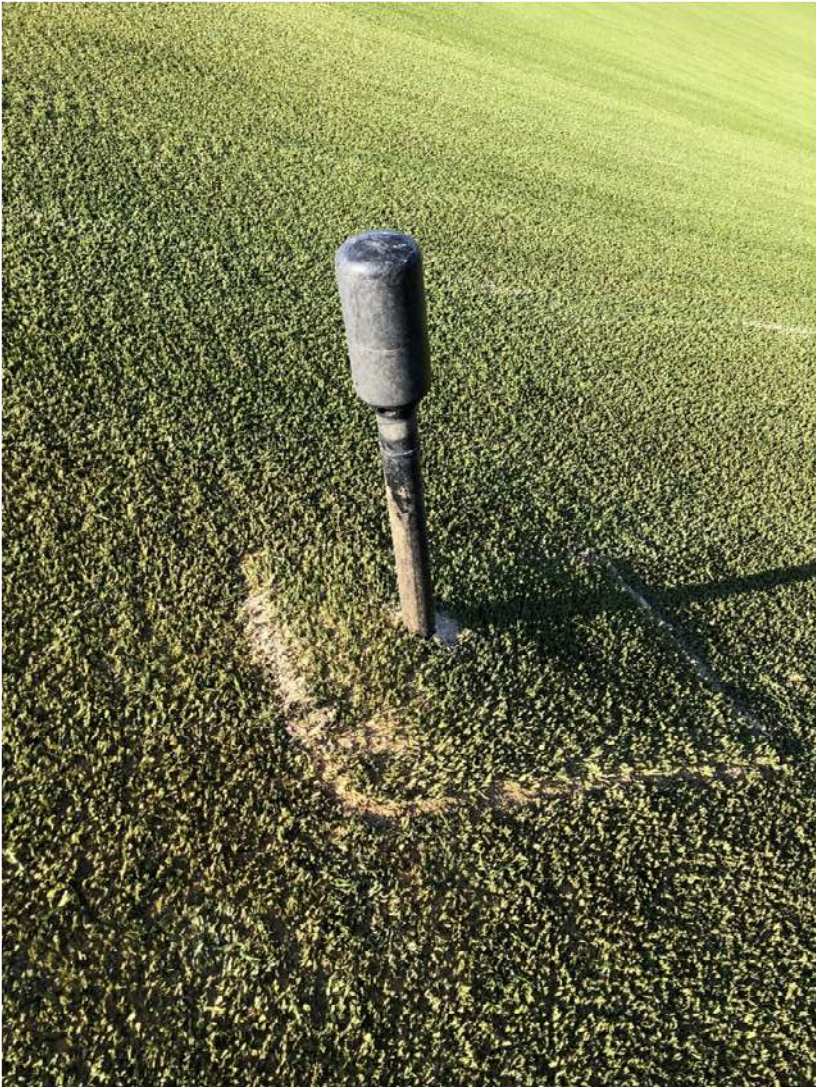
- Malfunction Relief Valve

- Active gas collection not required but passive venting needed to be accounted for...CT system has malfunction relief valves for gas accumulation (approximately 1 per acre).
- Passive gas vents were drilled into the waste mass for additional passive gas collection.
- Perimeter roads/grades were redesigned to accommodate anchor trenches and revised ponds.

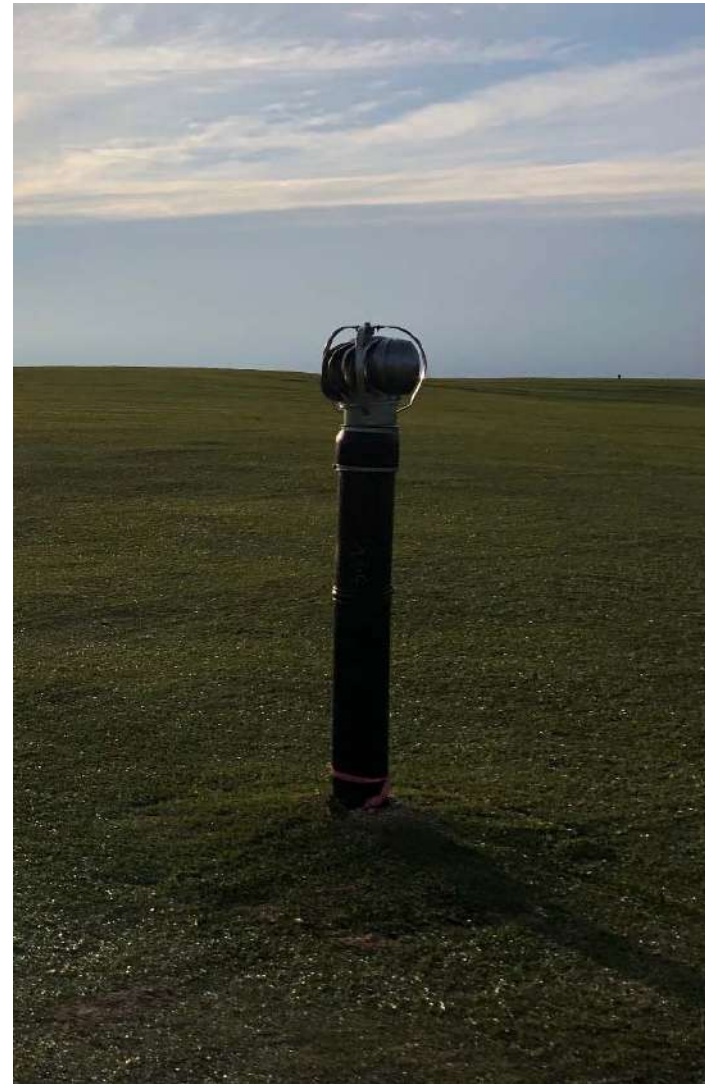
- Passive gas vent

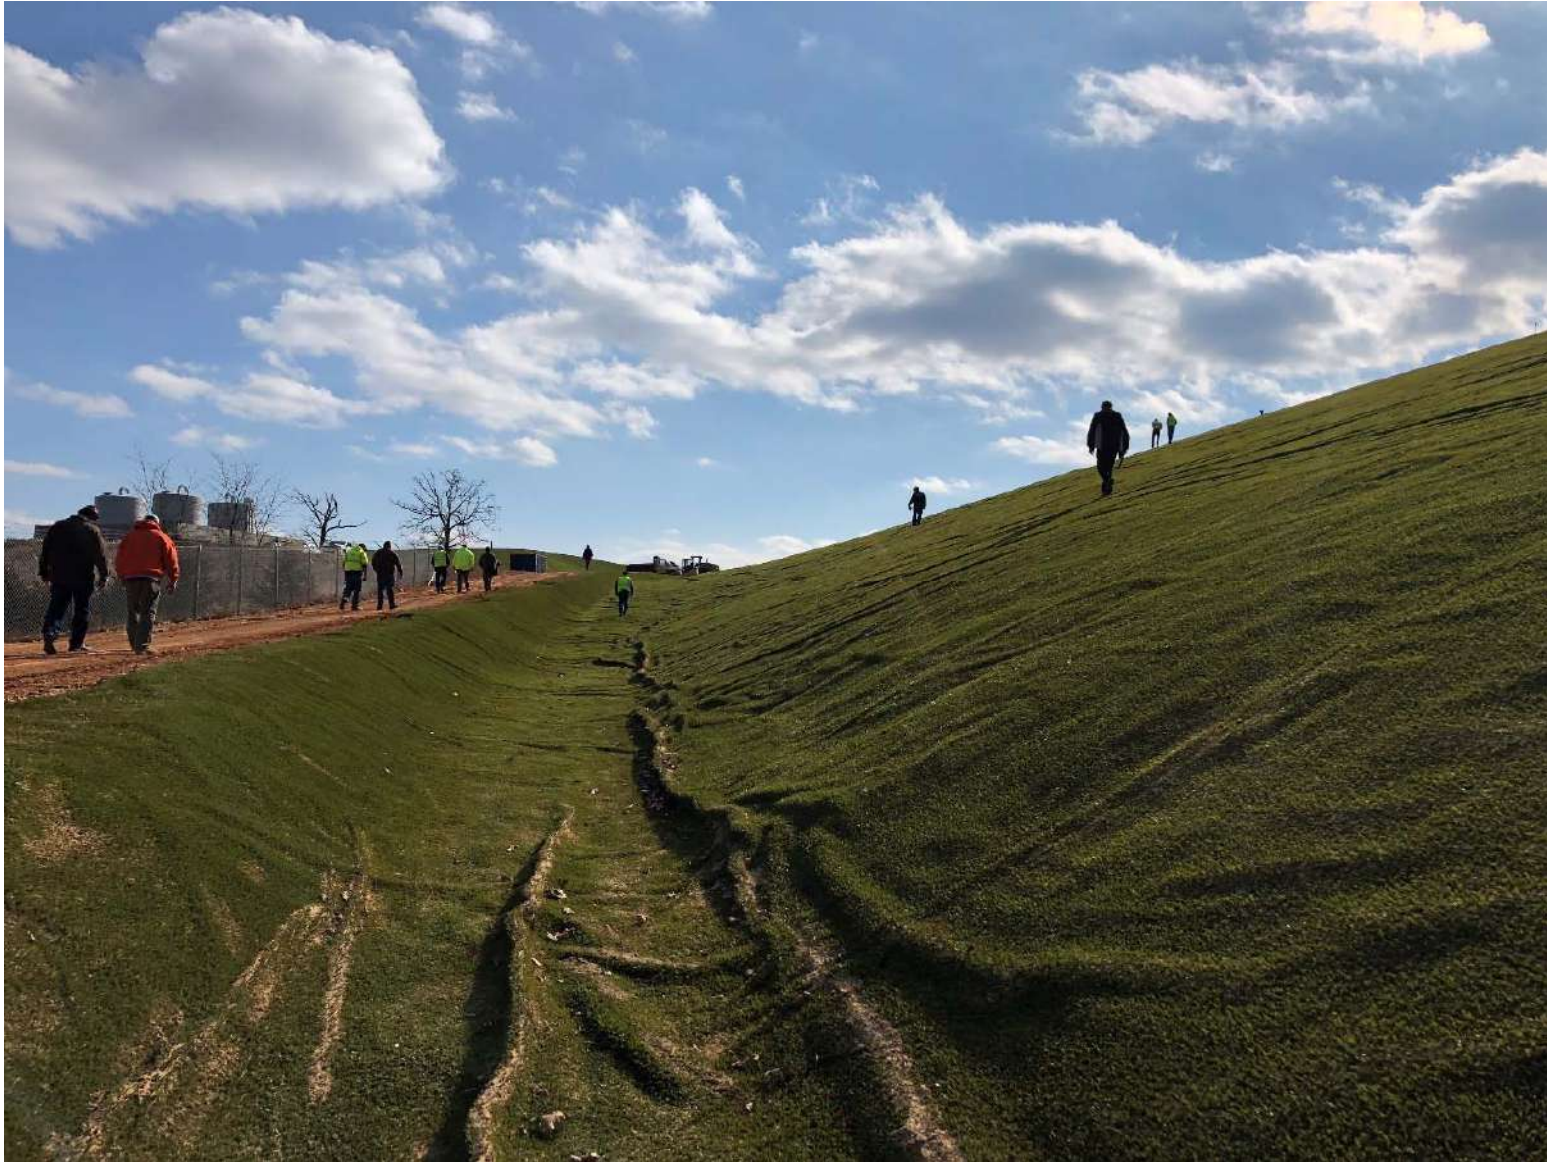
Challenges - Wrinkles

- Large wrinkles developed on Areas 1-2 and 1-3:
 - We think the waste relocation/regrading activities created differential settlement.
 - We were told the site didn't always use compaction equipment when they were open.
 - Wrinkles developed over time and moved towards the perimeter stormwater channel.
 - Wrinkles larger than 1 foot in height were cut out and repaired.
 - Did not appear to impede stormwater flow since they were oriented along the flow line.

- Stormwater discharge is very clear!
- Installation of the ClosureTurf® was quick outside of the sand infill which was greatly effected by weather. WatershedGeo has developed a sand spec to eliminate the need for ArmorFill.
- The wrinkles that developed did not effect stormwater drainage...more of an aesthetic issue.
- Sharp angles in the stormwater channels/terrace were difficult to construct...would recommend design with gradual angles.
- Would look into HDPE culverts/headwalls so the CT could be welded to the outlet structures.

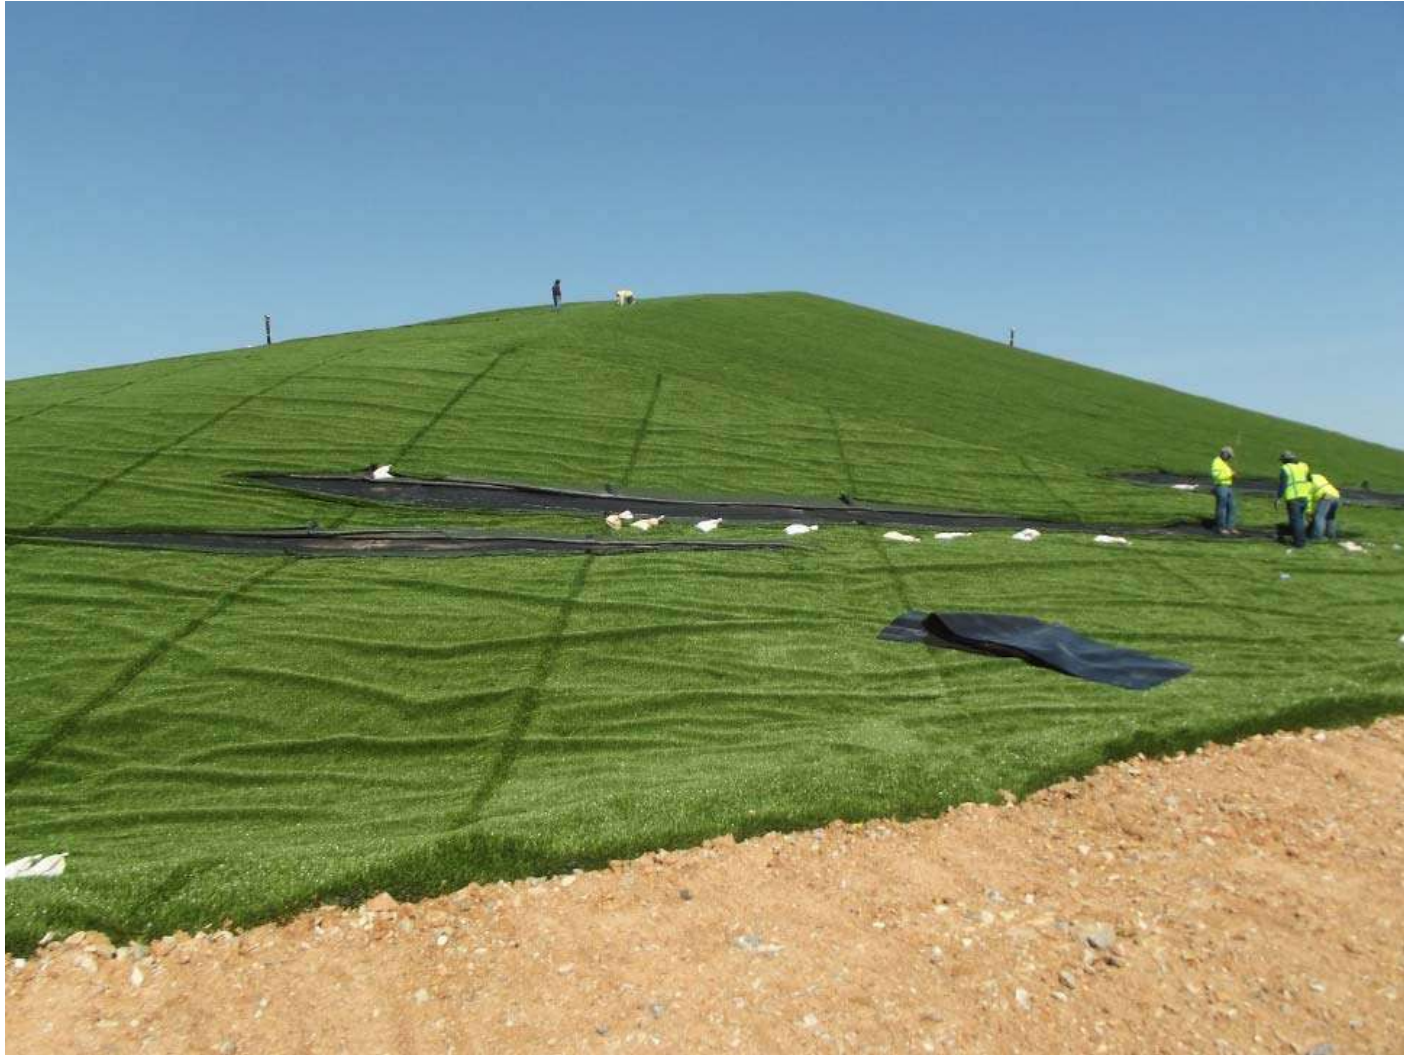
- Repairing wrinkles after ArmorFill installation was challenging as it was very hard to cut through.

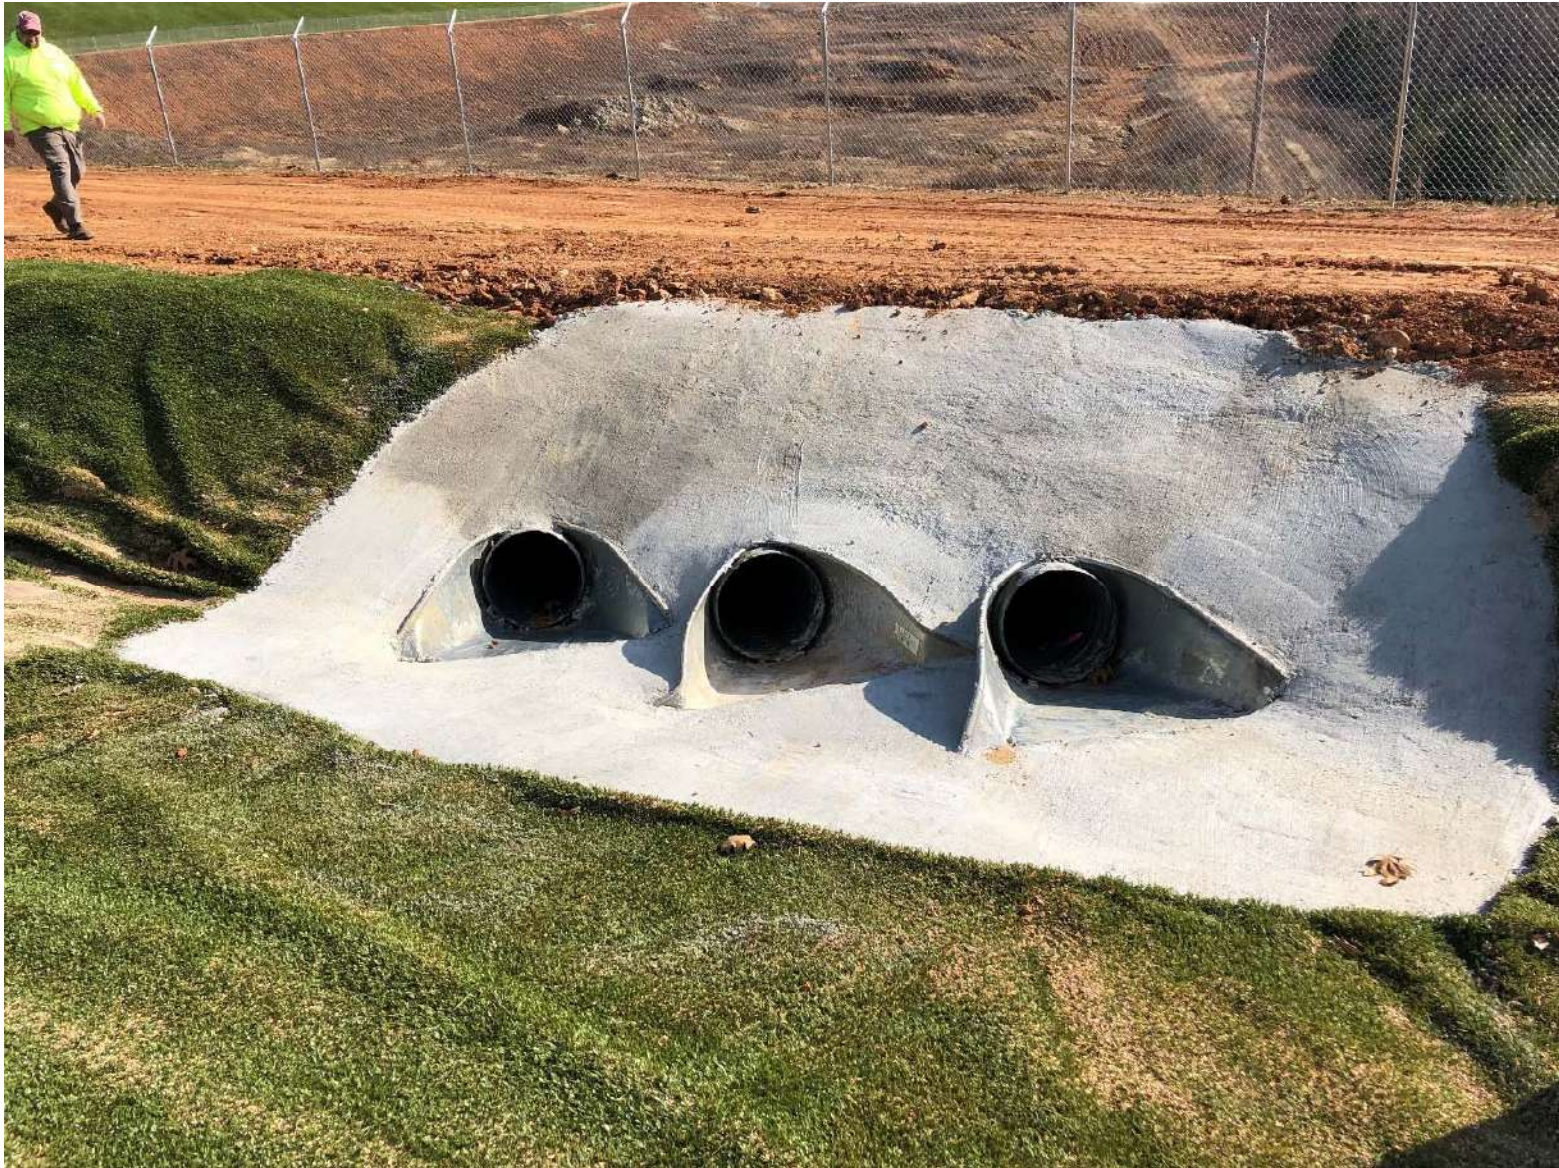
Challenges - Culverts

- Existing culverts were CMP and was difficult to tie the CT into.
- Poured concrete around the headwalls.
- Secured CT to the concrete using steel battens.
